Information Update

Subject **Work scope for 3B Passat
Pollen Filter Housing Seal**

Info 443/06 Reference
2 Pages
0845 641 9796 Contact

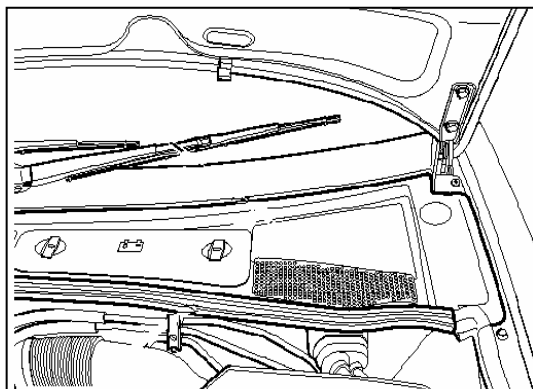
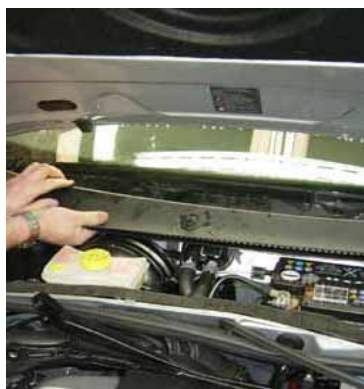
The outer seal (the countersunk closed foam seal) of the pollen filter housing may become saturated over time and in some cases degrade. As a result, it is also prone to splitting. Water can then penetrate this seal and enter the vehicles interior.

1. Remove plenum chamber cover and wipers/scuttle panel to allow access to the pollen filter housing. Remove plastic drain channel above filter.
